# North Red Deer Regional Wastewater Services Commission

**May 21, 2019**

NRDRWWSC Technical Memo#18

This Tech Memo summarizes the concerns found with the Sulzer pumps on the NRDRWWSC Lacombe Lift Station since commissioning of the facility, the actions taken to date, and the recommended next steps.

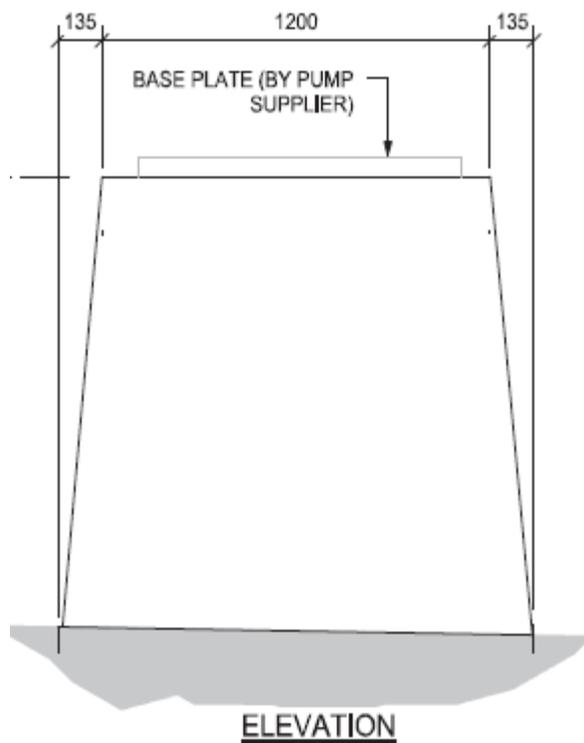
Drawing from Stantec

Stantec drawing:

- 58" length at the base vs Actual on site is 42"
- 48" top across length vs Actual on site is 42"

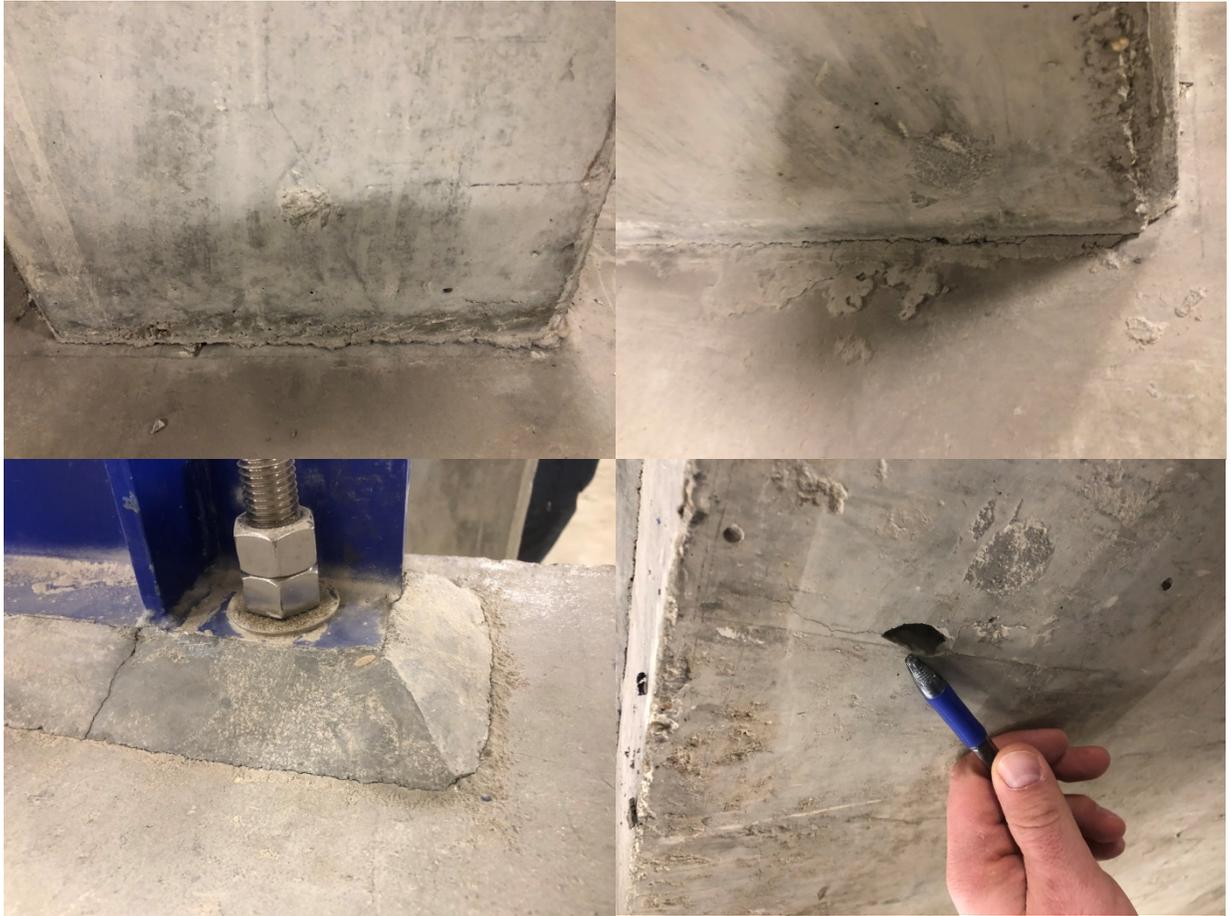
**2. Poor finished Concrete bases:** The bases show many cracks and holes.

Below are pictures taken from the site:

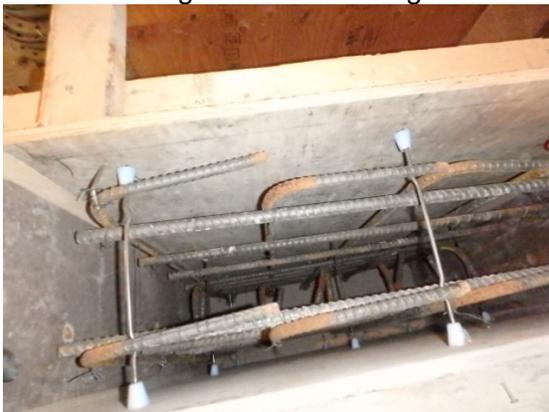
## Lacombe PS

The concrete pouring is visible in Lacombe vs in Blackfalds. Below are pictures taken from different stations during construction stage.

The fixing of the steel bars of the plinth appears to be not sufficient to become “one unit” with the concrete floor. This is paramount so that any kind of created forces and torques can be absorbed by the building and hence Pump vibration gets then reduced.

We recommend to fix/glue the plinth using chemical dowels of the type: M24 rods and HILTI HIT RE. Per each plinth 8x should be used and drilled inclined into the plinth.

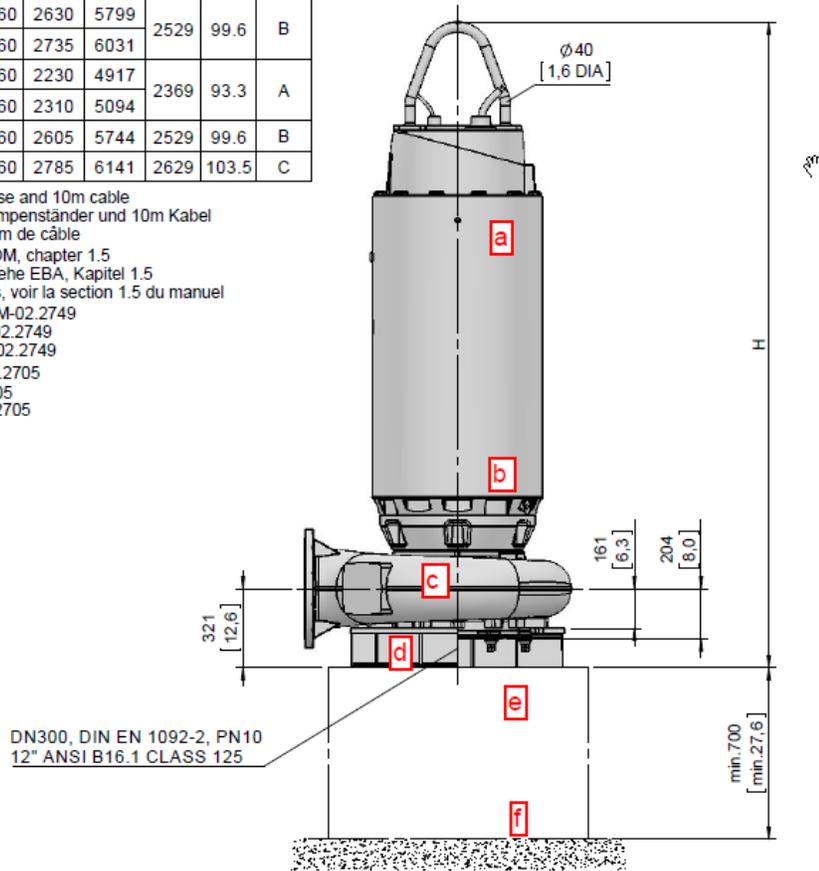
- 3. Excessive Vibration:** All pumps are tested at the factory, conformity with ISO10816-7 standard. However, both #102 and #103 pump site vibration measurements have exceeded the factory data.

Actual measurement on pump #103, at 1152m<sup>3</sup>/h, the Velocity RMS value is 10.668mm/s (point A), 4.826mm/s (point B) and 12.7mm/s (point C).

Lacombe Data Collection				
60Hz - Pump 103 - 320 l/s @ 544 KPA				
Point on Unit	G	IPS	MM/S	Mil
A	1.19	0.42	10.668	6.8
B	1.4	0.19	4.826	2.1
C	3	0.5	12.7	6.2
D	1.8	0.34	8.636	4.8
E	0.55	0.36	9.144	5
F	0.23	0.04	1.016	0.9

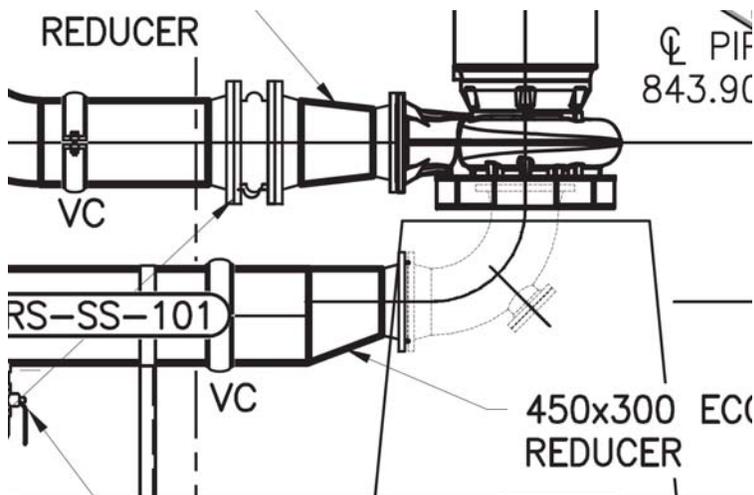
- 4. Suction pipe reducer and suction elbow:** The suction pipe reducer (450 x 300mm) right before the 90 degree suction elbow (300 x 300mm) leads to a high flow speed and flow separation creating non-uniform inflow into the impeller.

As a CFD study in another similar installation, a short radial elbow can create uneven flow (in RED).

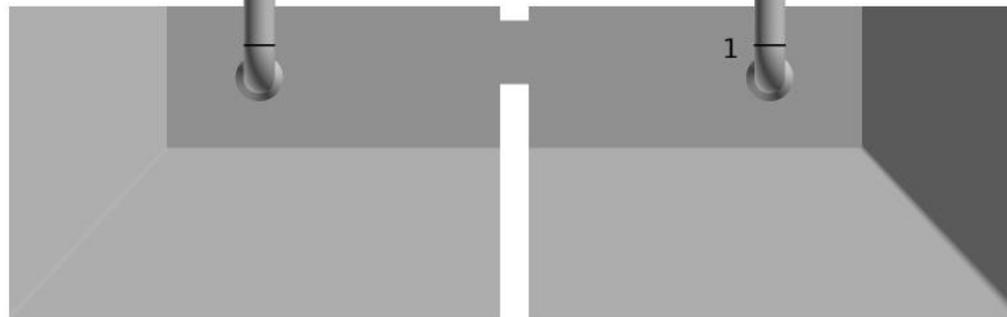
Case No. 3  
RSP-101 Flow: 320 l/s  
Existing Design

Excessive swirl angles!

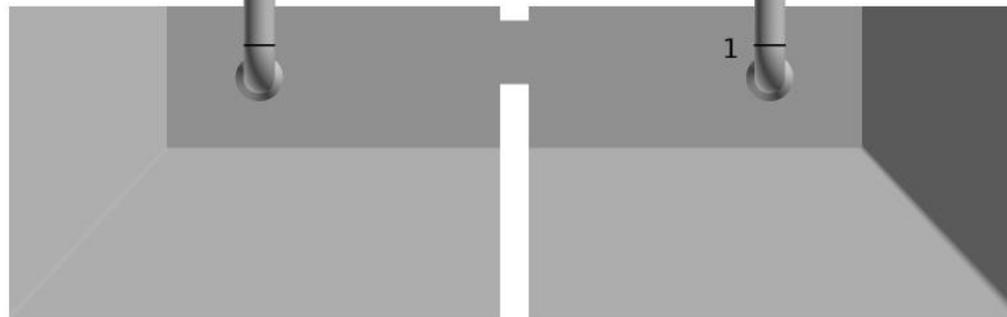
Case No. 4  
RSP-101 Flow: 190 l/s  
Existing Design

Excessive swirl angles!

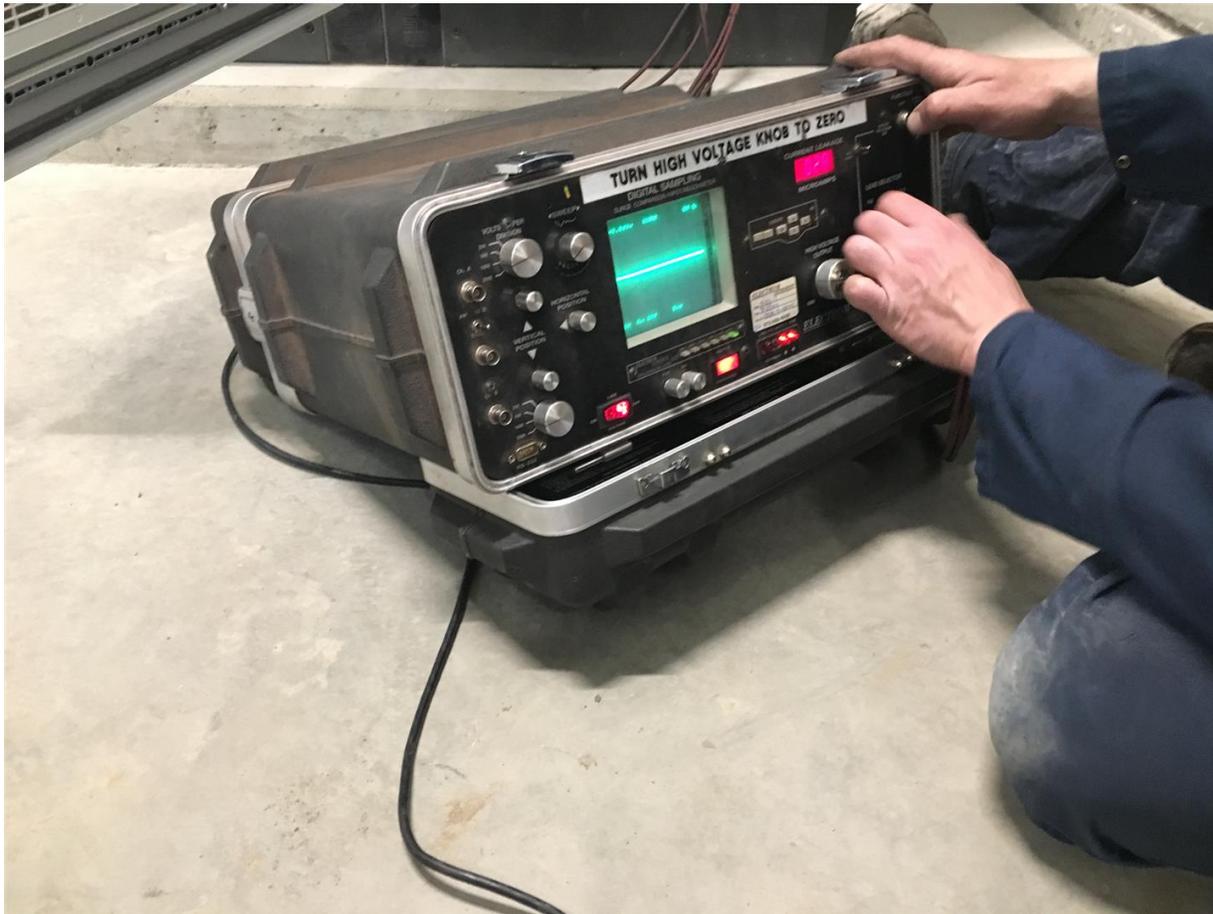
Figure 4: Blackfalds Regional Lift Station – onsite electrical testing of Blackfalds RSP-102

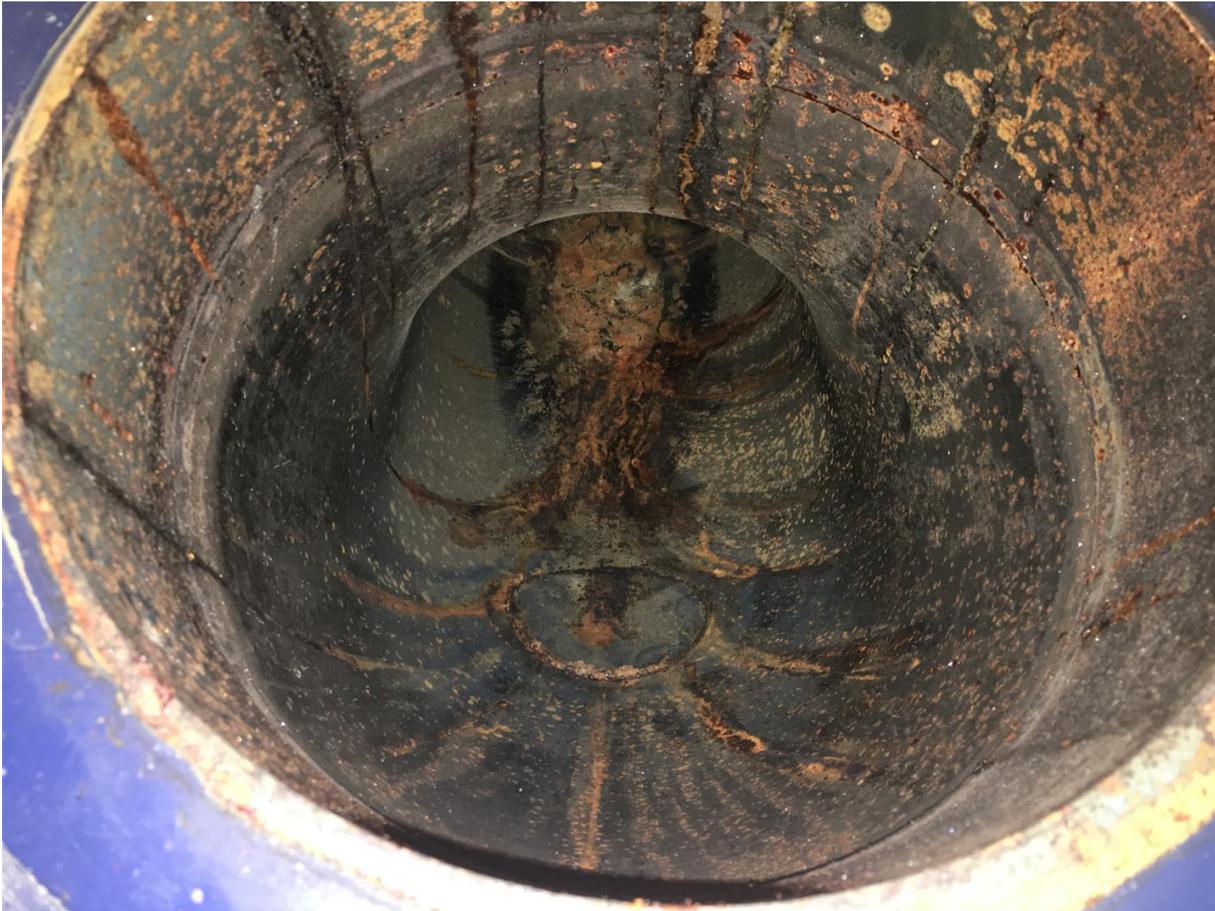
Figure 7: Lacombe Regional Lift Station – no signs of cavitation on RSP-102's elbow.
